Państwowe  
Gospodarstwo Wodne  
Wody Polskie

XLII  
International School  
of Hydraulics

# FLOOD IN SEPTEMBER 2024 – Hydrological Analysis, Infrastructure Functionality and Consequences

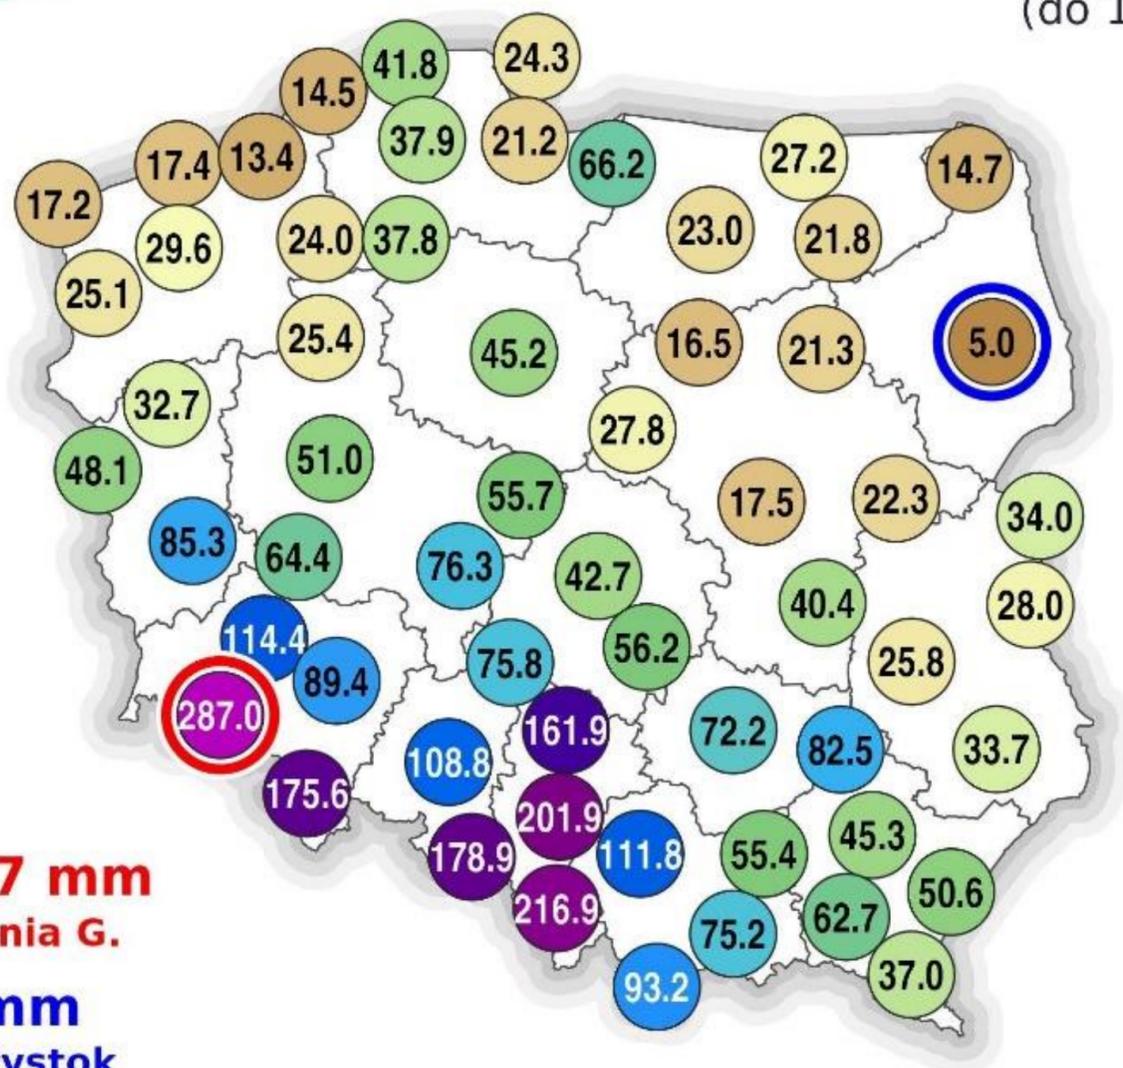
**Suma opadu** **WRZESIEŃ 2024**  
(do 15.09)

**287 mm**  
Jelenia G.

**5 mm**  
Białystok

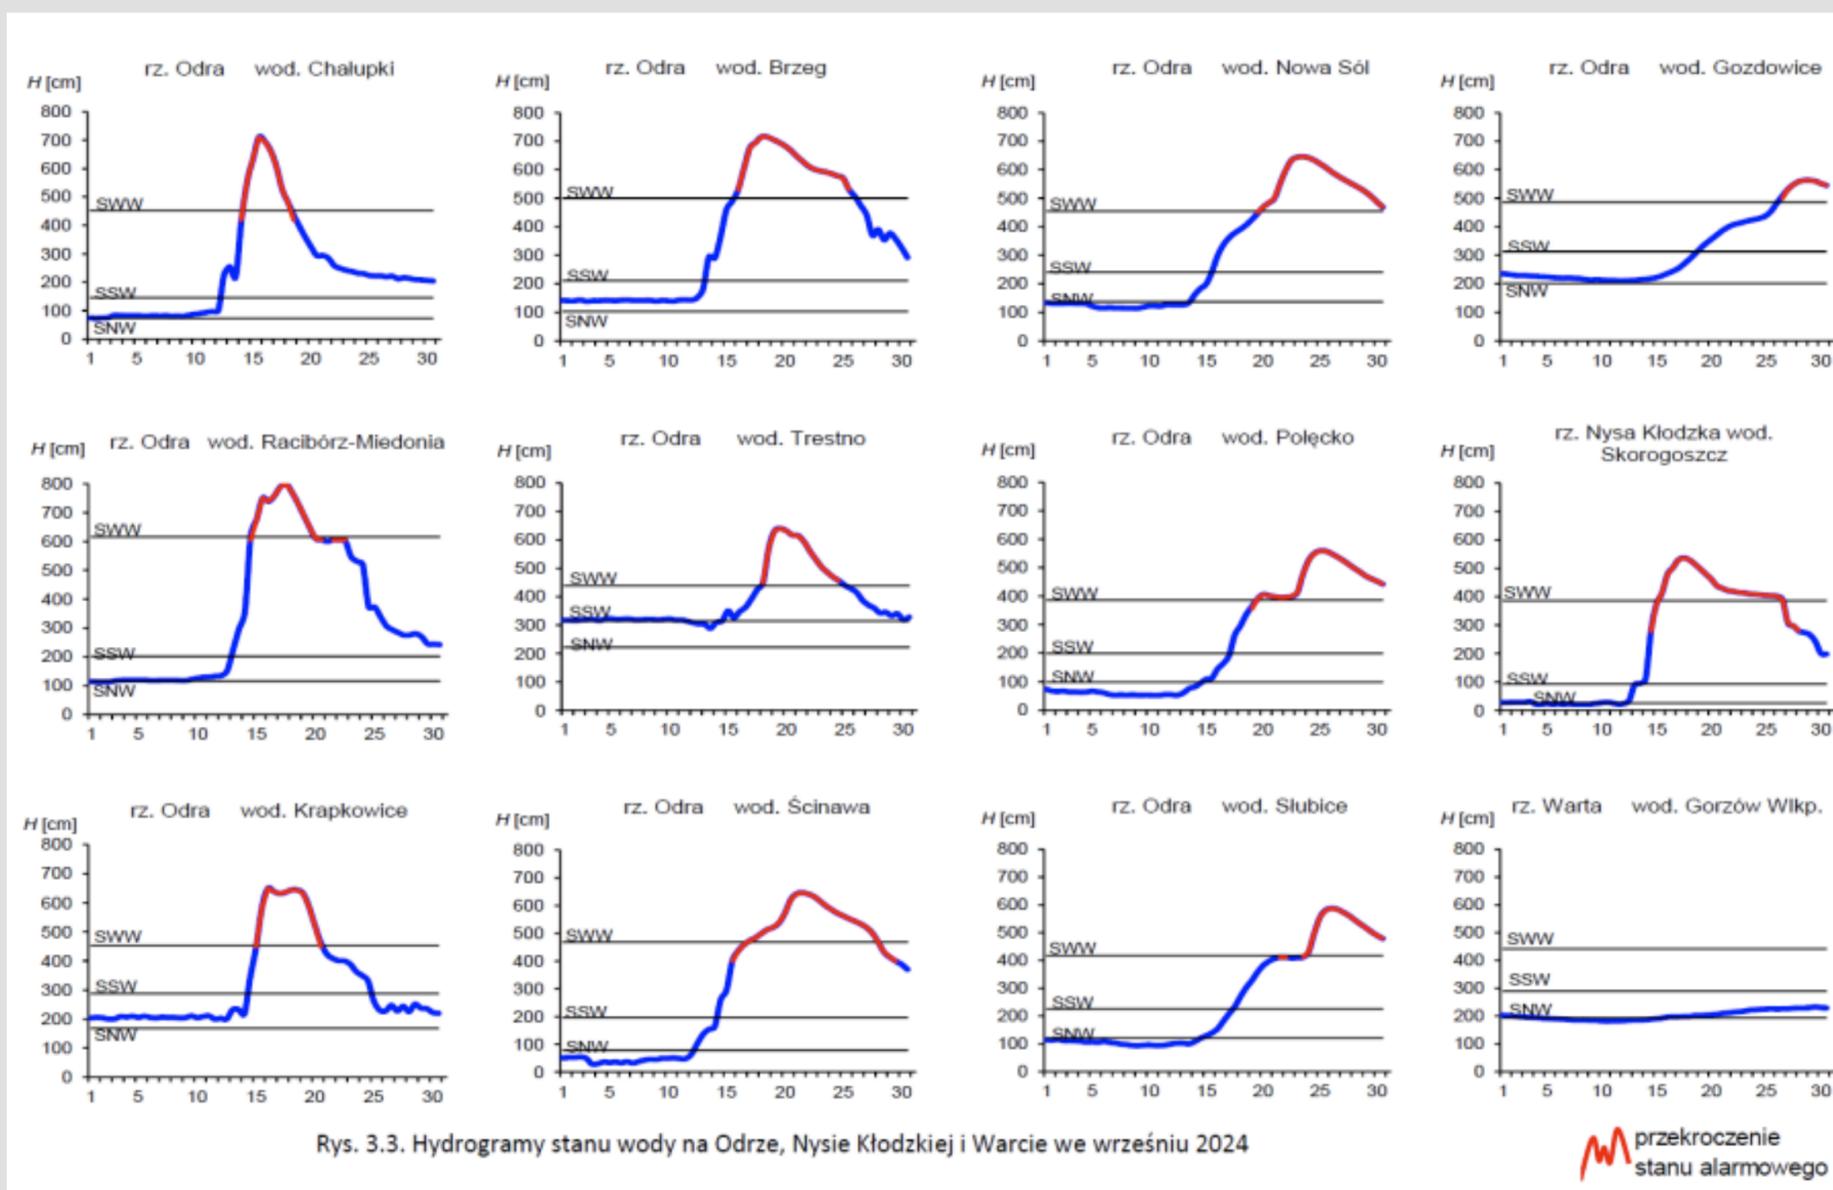
- After extremely high rainfall on 13-15 September, flood waves formed rapidly on the rivers of the upper and middle Oder basins, which exceeded the alarm level extremely quickly. The highest number of exceedances of the alarm level: **81 was recorded on 16 September**. After 16 September, the number of exceedances of the alarm level in the Oder basin systematically decreased, while on the Oder itself it increased, as a result of the movement of the flood wave. At the end of the second decade, almost the entire Oder (with the exception of the estuary zone) was recorded with high water levels, generally with exceedances of the alarm level, much less often the warning level.

- The highest number of exceedances of the alarm level in the Vistula basin: **21 was recorded on 15 September**. After 16 September, high rainfall was no longer recorded in the whole of Poland and in both basins drops in water level prevailed. On the last day of the month, the water level in the Vistula basin and on the Vistula was generally in the low water zone.

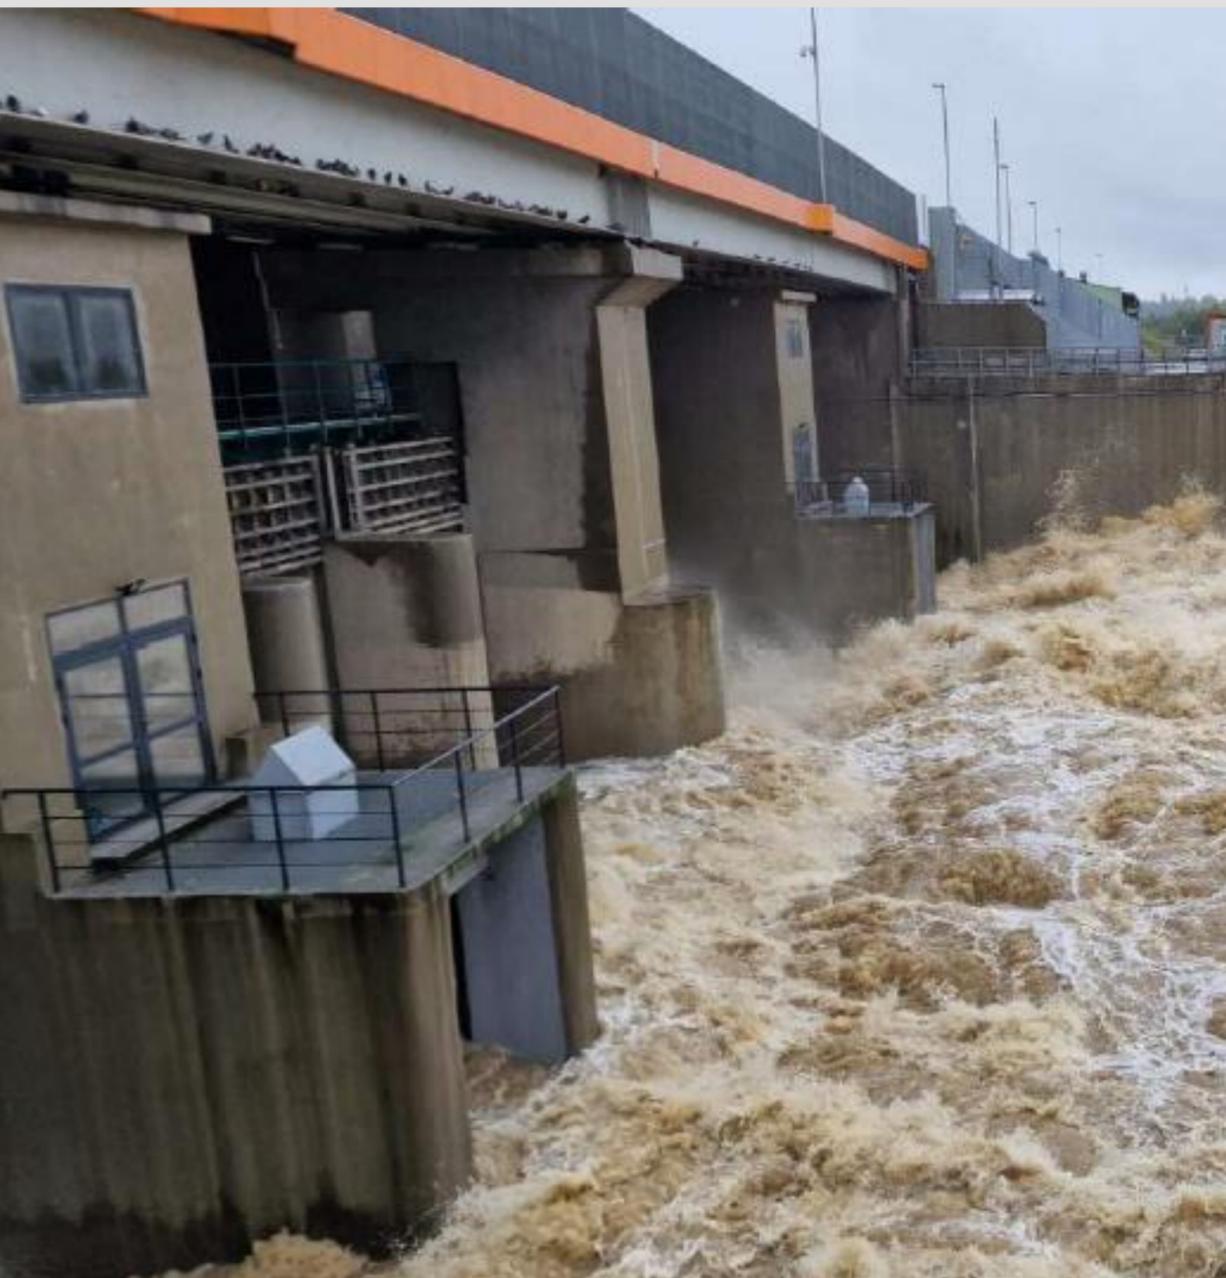
## Reservoirs of the Nysa Kłodzka cascade

- Before the flood, the Nysa Kłodzka cascade reservoirs had a total free capacity of 177 million  $\text{m}^3$ , which is comparable to the capacity of the Racibórz Dolny flood protection reservoir on the Oder.

- On Saturday, September 14, as a result of heavy rainfall and rising water levels, work on the Nysa Kłodzka cascade reservoirs entered flood mode.
- The inflow to the reservoirs of 2,030  $\text{m}^3/\text{s}$  was reduced to an outflow from the Nysa reservoir of 1,000  $\text{m}^3/\text{s}$ .

- The Nysa Kłodzka cascade reservoirs captured approximately 155 million  $\text{m}^3$  of water, reducing the flood wave below the reservoir.
- The flood in the city of Nysa did not occur from the Nysa Kłodzka river and the Nysa reservoir. The outflow from the Nysa reservoir did not exceed 1000  $\text{m}^3/\text{s}$ . The water flow of the Biała Głuchołaska River took place from the towns of Przełęk and Biała Nyska through the fields along the right side of the side dam of the Nysa reservoir towards the city of Nysa.

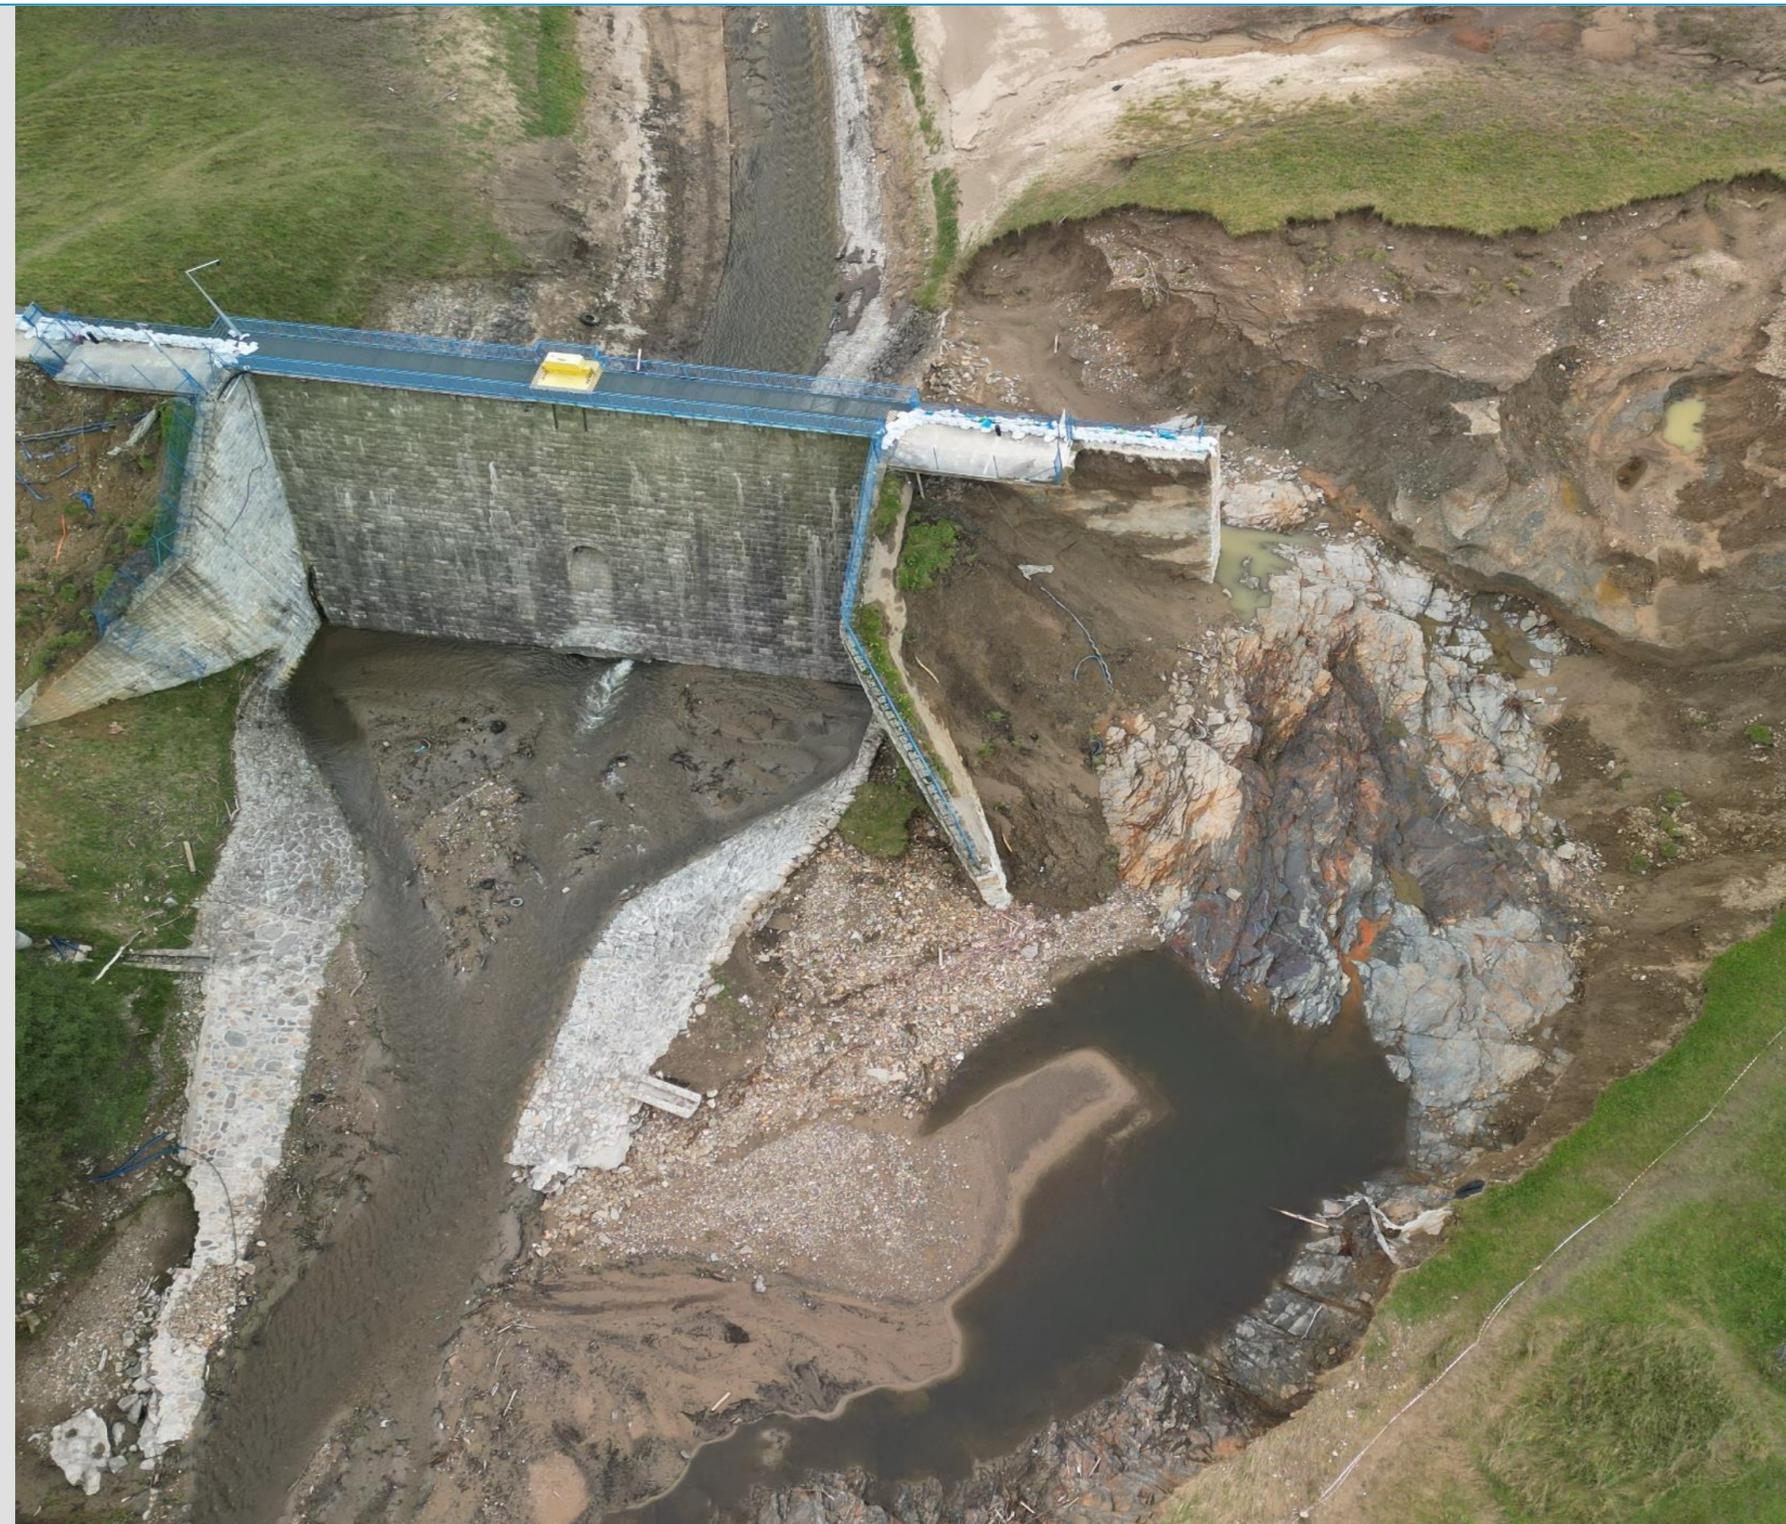
### Stronie Śląskie Reservoir

The Stronie Śląskie dry flood control reservoir located on the Morawka stream, a left-bank tributary of the Biała Łądecka, was built in 1907. The Stronie Śląskie reservoir began to accumulate water on Friday, September 13. On Sunday, September 15, the reservoir's earth dam was destroyed as a result of water overflowing through its left section. The reservoir was designed for a flow of 70-80 m<sup>3</sup>/s, and it is estimated that it received a flood wave of 320 m<sup>3</sup>/s, which is four times greater.

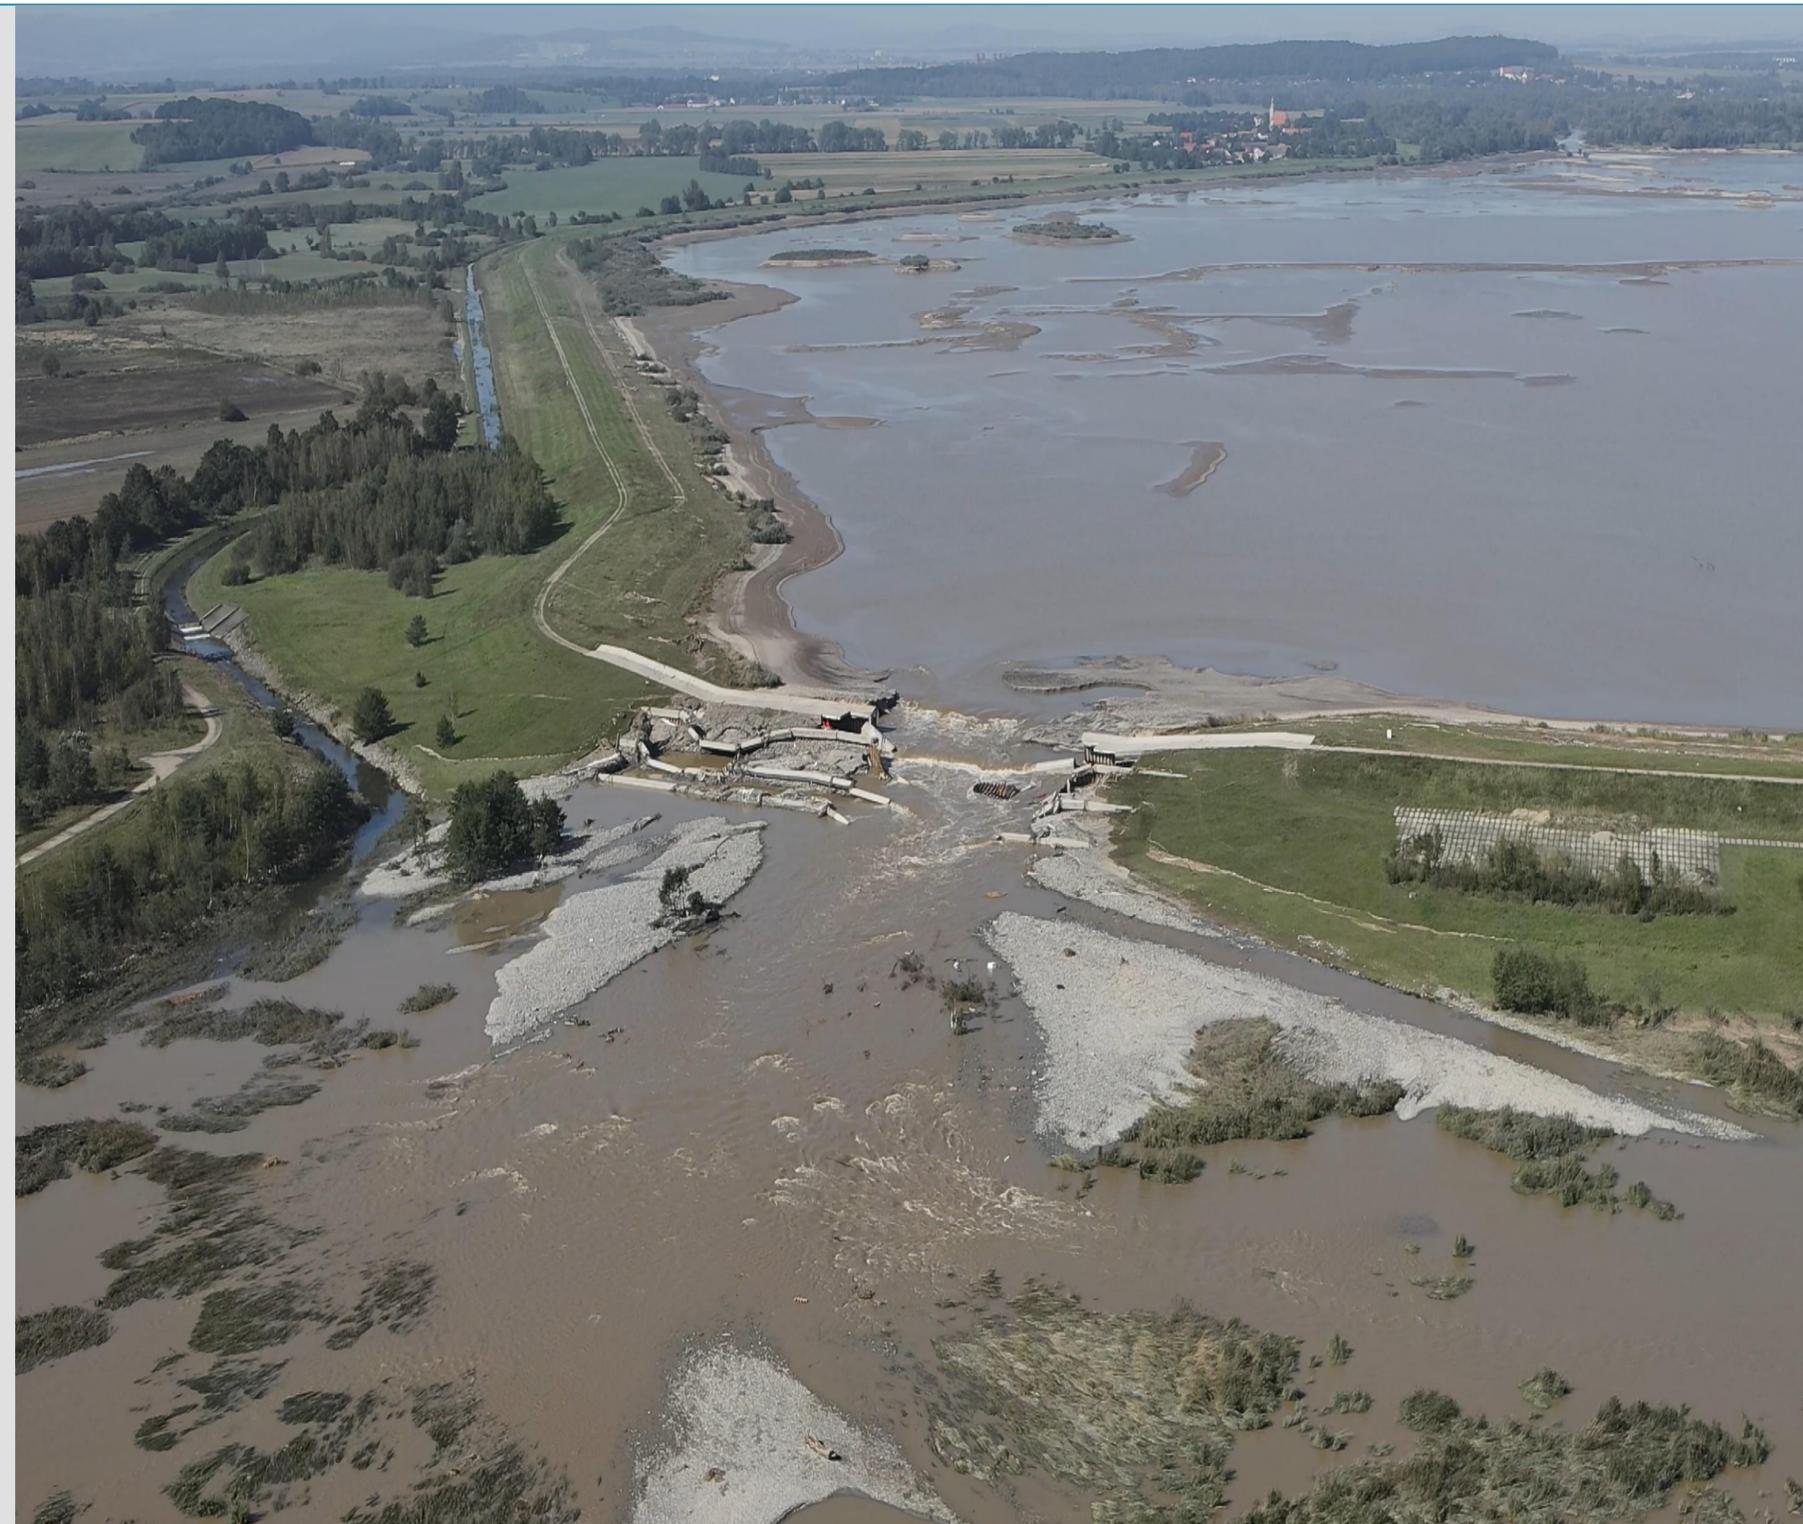
### Topola Reservoir

On September 16, the side surface spillway of the reservoir was damaged. This failure did not pose a threat to the towns below. The entire flood wave was absorbed by the Otmuchów and Nysa reservoirs.

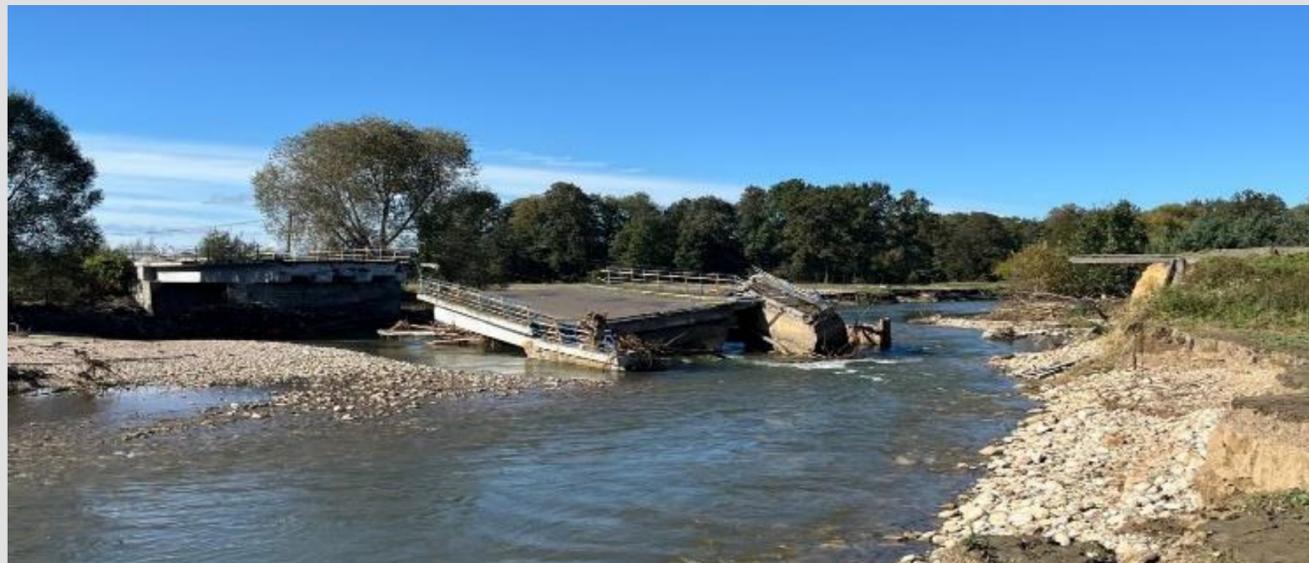
### Road infrastructure losses

The total length of damaged roads is approximately **3 633 km**. Approximately **127 km of bicycle paths**, **229 bridges** and **1,823 culverts** were also destroyed. The largest losses were recorded in the Lower Silesian Voivodeship. The amount of losses caused by flooding in this area in terms of road infrastructure was estimated at **7 639 297 072,60 zł**.
